Sun Fire™ V20z and Sun Fire V40z Servers

Release Notes

Part No. 817-5252-18
December 2004 Revision A

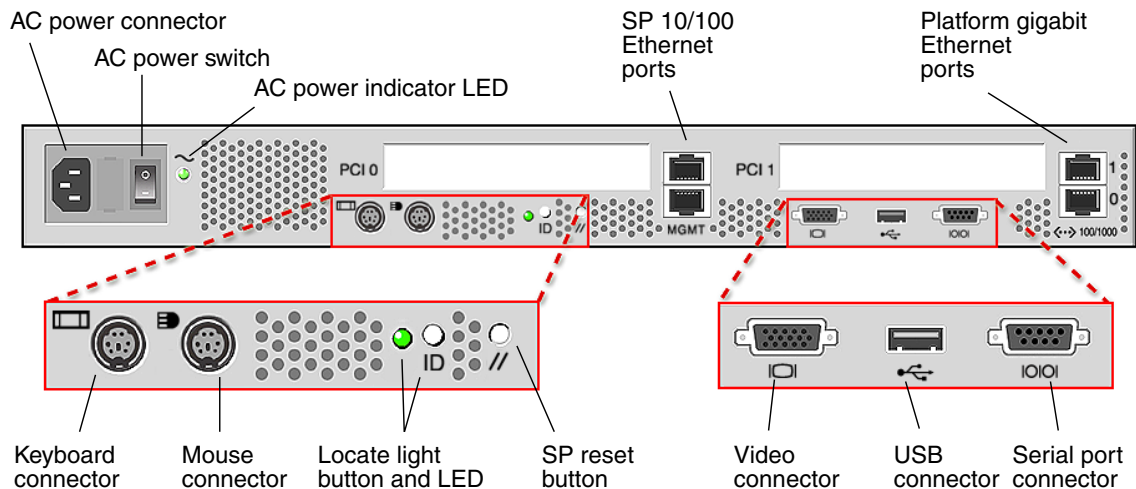
FIGURE 1 Sun Fire V20z Server Back Panel

It is important to note the labelling of the Ethernet ports on the server back panel. As shown on the far right side of the server illustrated in [FIGURE 1](#), interfaces eth1 and eth0 are labelled as “1” on the upper port and “0” on the bottom port, respectively.

The PCI slots are labelled on the server back panel as PCI 0 (next to the power supply) and PCI 1 (between the SP and platform ethernet ports). See [FIGURE 1](#).

If you install only one PCI card in the Sun Fire V20z server, we recommend that you install it in PCI slot 0 (the slot closer to the power supply; see [FIGURE 1](#)) in order to obtain better system performance.

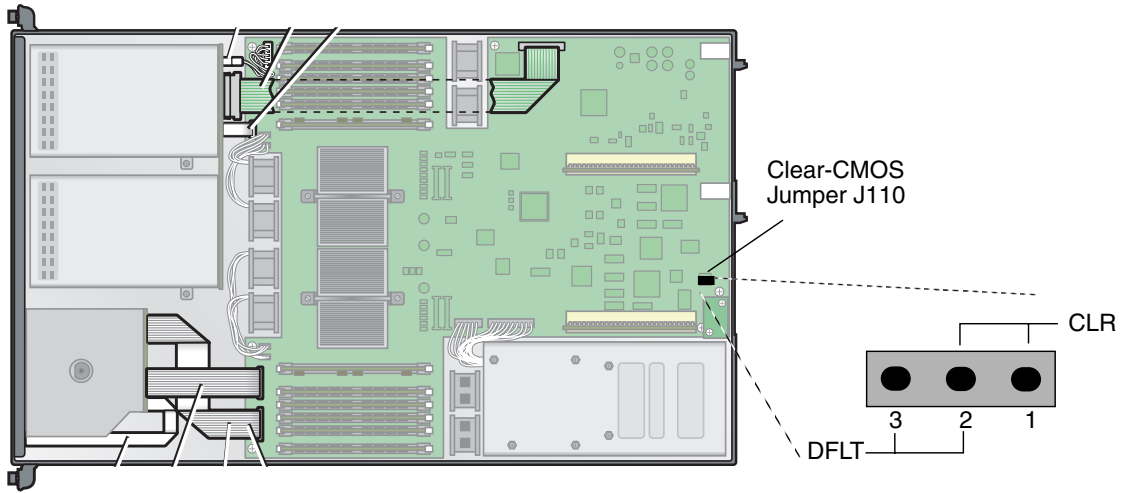
The location of the Clear-CMOS jumper (J110) on the Sun Fire V20z motherboard is shown in [FIGURE 2](#).

- The default position for the jumper is pins 2+3, which is the setting for “Clear-CMOS-Removed.” This setting retains CMOS settings on each reboot of the server.
- If you move the jumper to pins 1+2, this is the “Clear-CMOS-Installed” setting. This setting will clear the CMOS settings with each reboot of the server.

FIGURE 2 Sun Fire V20z Motherboard, Showing Clear-CMOS Jumper J110

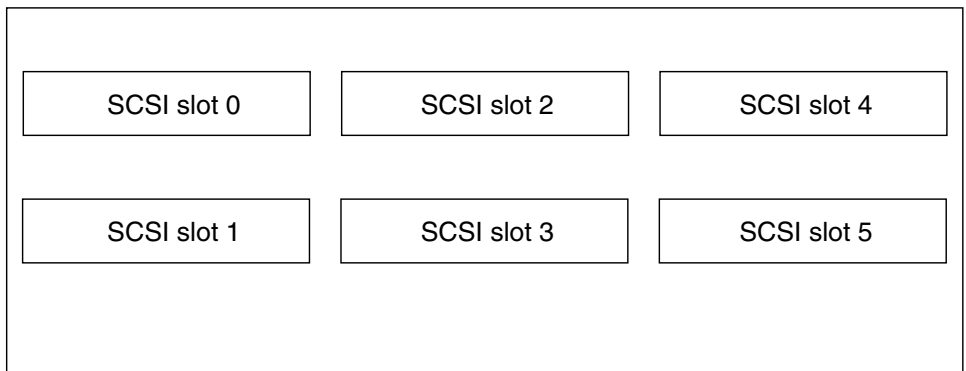
The ID assignments of the SCSI connectors on the SCSI backplane are shown in [FIGURE 3](#), when viewing the HDDs from the front of the server.

FIGURE 3 HDD SCSI Slot Numbering

If you install the optional sixth HDD adapter (as described in the User Guide [817-5248]), SCSI slot 5 can be used for a SCSI HDD instead of a DVD/diskette drive assembly

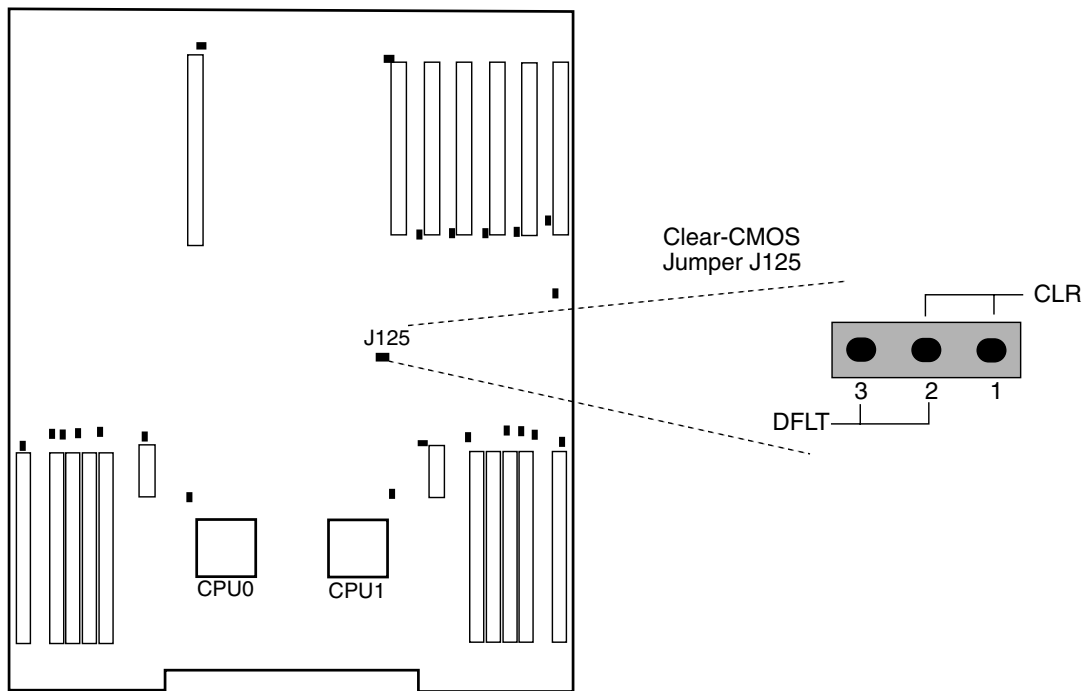
The location of the Clear-CMOS jumper (J125) on the Sun Fire V40z motherboard is shown in [FIGURE 4](#). This jumper can be used to clear the CMOS if the server hangs during certain conditions.

- The default position for the jumper is pins 2+3, which is the setting for “Clear-CMOS-Removed.” This setting retains CMOS settings on each reboot of the server.
- If you move the jumper to pins 1+2, this is the “Clear-CMOS-Installed” setting. This setting will clear the CMOS settings with each reboot of the server.

FIGURE 4 Sun Fire V40z Motherboard, Showing Clear-CMOS Jumper J125
